Case Study: Successful Living Shoreline Group 1 General Permit

Project Name: Hampton River Living Shoreline

Location: Western shoreline of Herberts Creek, Hampton, VA

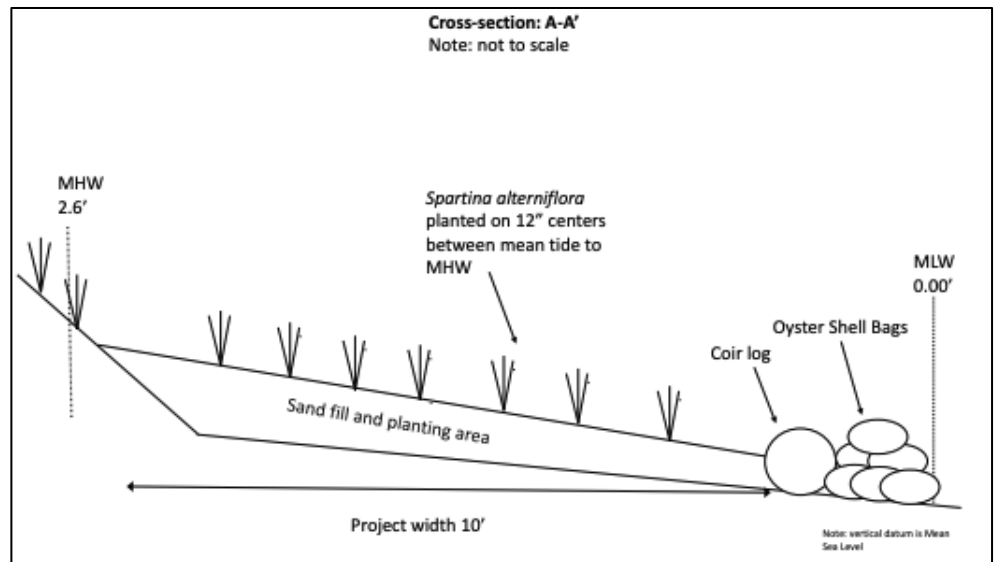
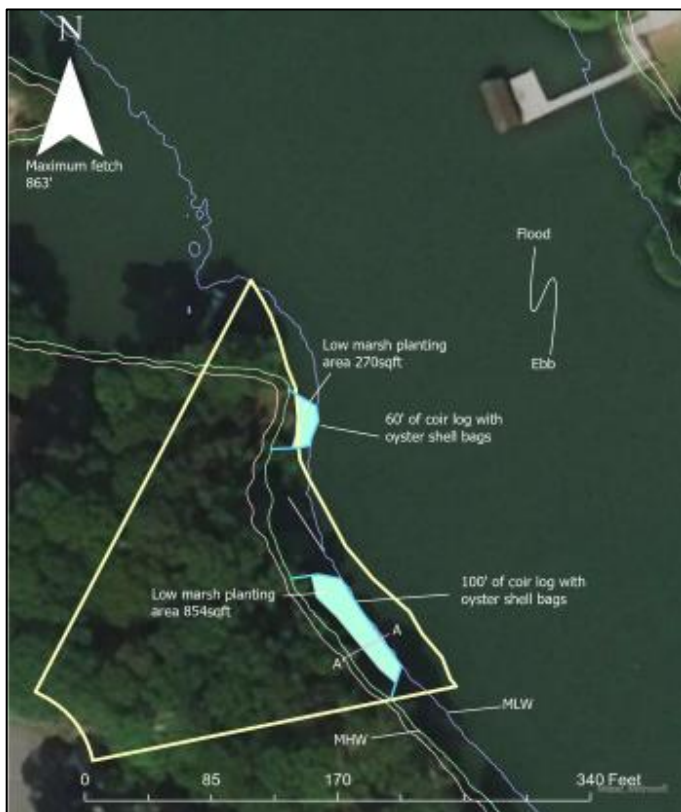
Project Description: Along the section of shoreline where the living shoreline was to be installed was rubble concrete. Before living shoreline installation began, all rubble concrete was removed. This living shoreline project consisted of two sections (100 linear feet and 60 linear feet) of 16" coconut fiber coir logs covered by oyster shell bags that were placed at mean low water and tied to mean high water. Behind each coir log section, clean coarse grade sand was placed then planted with native salt marsh vegetation (*Spartina alterniflora*).

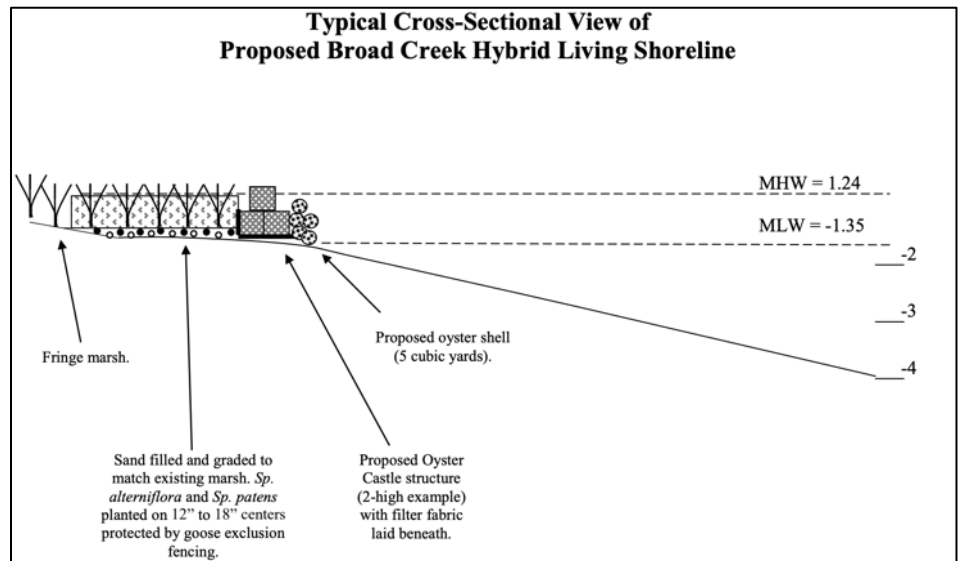
Project Description: This living shoreline project consisted of two sections of oyster castles (40 linear feet and 50 linear feet) and one section of coir logs (74 linear feet). The two Oyster Castle sills were built by stacking Oyster Castles 2- or 3-high with oyster shells placed on top of sills and channelward. The coir logs used for the single coir log section were either 12" or 16" in diameter. All three sections were placed above mean low water. Behind the hybrid living shoreline, clean sand (48 cubic yards) was placed and graded to existing elevation then planted with salt marsh vegetation (*Spartina alterniflora* and *Spartina patens*). Goose exclusion fence was placed around the perimeter of the planting area.

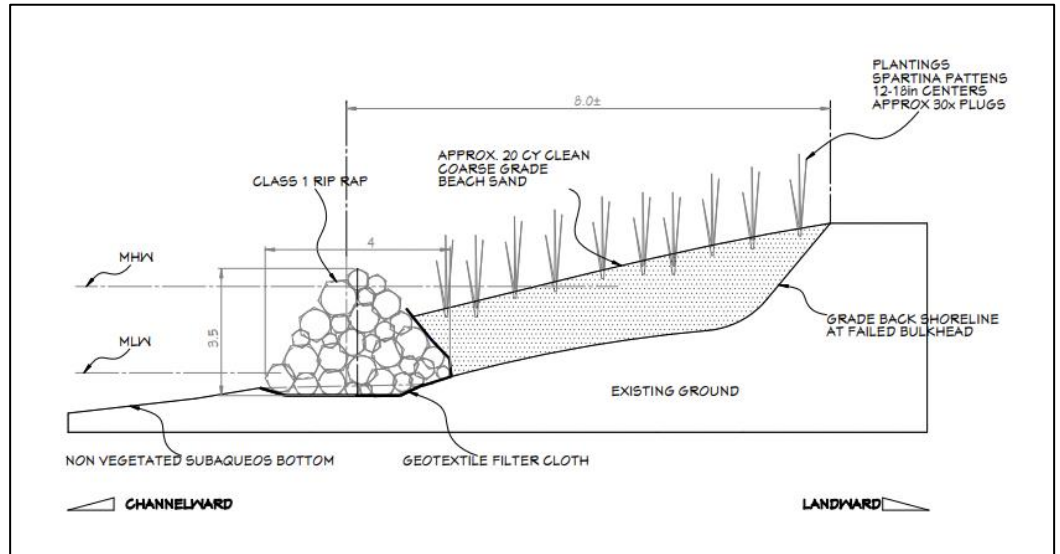
Project Description: The original project proposed was to replace a failing, wooden bulkhead with a rip rap revetment of approximately 90 linear feet. Additionally, the project included the installation of a 4-foot boardwalk landward of mean high water for safer water access. After the Poquoson Wetlands Board and Virginia Marine Resource Commission visited the project site, it was recommended that a new site plan be created to incorporate a living shoreline to meet regulatory requirements. Working with the homeowner, the marine construction company developed a site plan that replaced the failing bulkhead with a class 1 rip rap revetment and hybrid living shoreline along 40% of the shoreline. Once the failing bulkhead was removed, rip rap was installed along 40 linear feet of the shoreline and a living shoreline that incorporated a rock sill was installed along 60 linear feet of shoreline. Behind the hybrid living shoreline, clean sand was placed, then planted with salt marsh vegetation (*Spartina patens*).

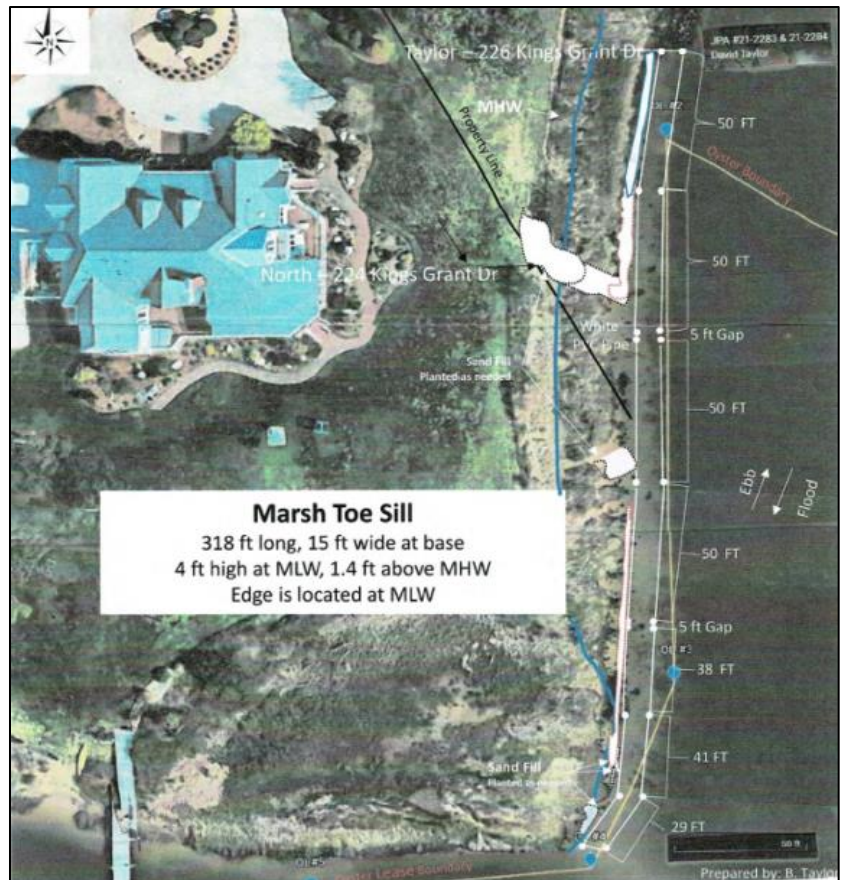
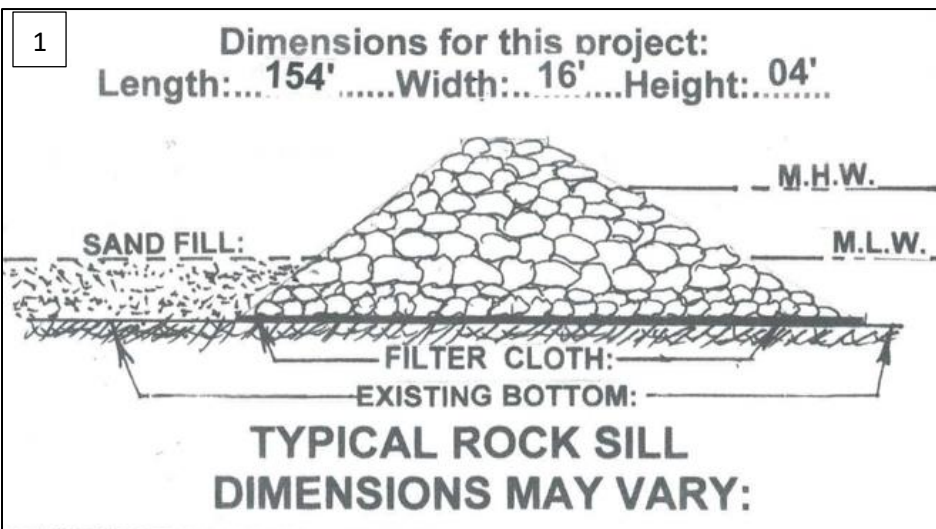
Project Description: This JPA proposed to install a rock sill in front of a vegetated wetland along two properties. The rock sill to be installed consisted of armor stone sill that would be placed on filter cloth and approximately 154 feet long, 2 feet high and 16 feet in base width. To improve wetland habitat, project proposed to place clean sand and plant appropriate wetland plants in front of marsh fringe.

Project Results: This project with modifications was approved for a Virginia Marine Resource Commission Subaqueous permit. Modifications to the original JPA included improved project site drawings and increased clarity in project design. Specifically, original drawing was of a typical rock sill (1) and needed to be site specific (2). Additionally, project sill height did not account for local sea level rise, and area of beach nourishment, limits of vegetated wetlands and benchmarks were missing in design. After modifications to original JPA, the site
